Vestibular syndrome after cochlear implantation

ABSTRACT

Vestibular syndrome after cochlear implantation is described in the literature. Its causes are variate but not always amenable to etiologic approach. We describe a patient which developed cochlear electrode extrusion with persistent vestibular symptoms after a successful insertion.

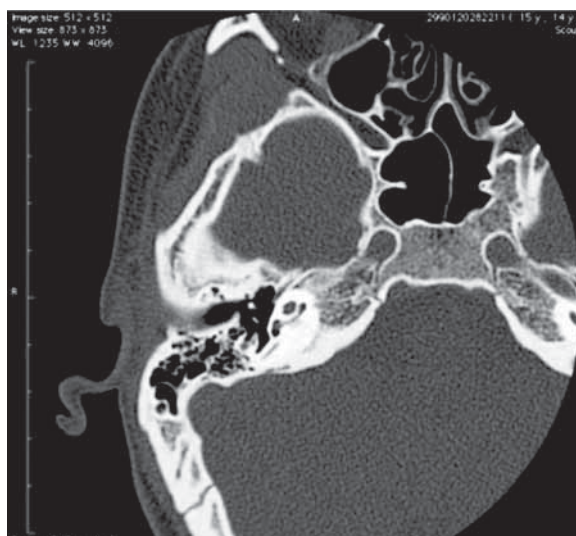
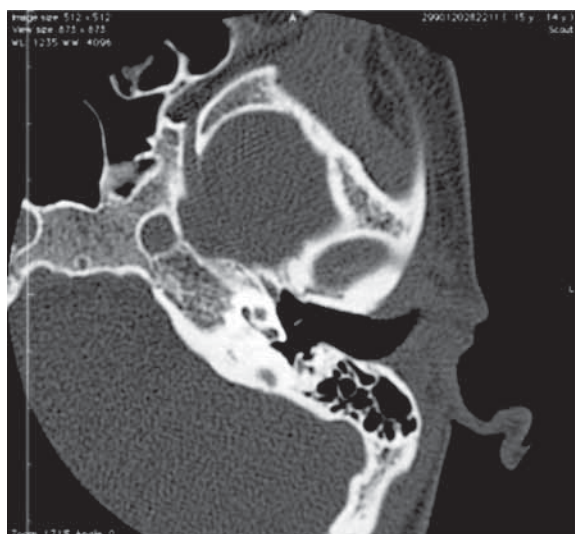
The preoperative imaging showed mild blurring (ossification?) at the top of the left cochlea (Fig. 1, 2).

FIGURE 1, 2. Discrete blurring of the cochlear apex on the left side (preoperative CT)

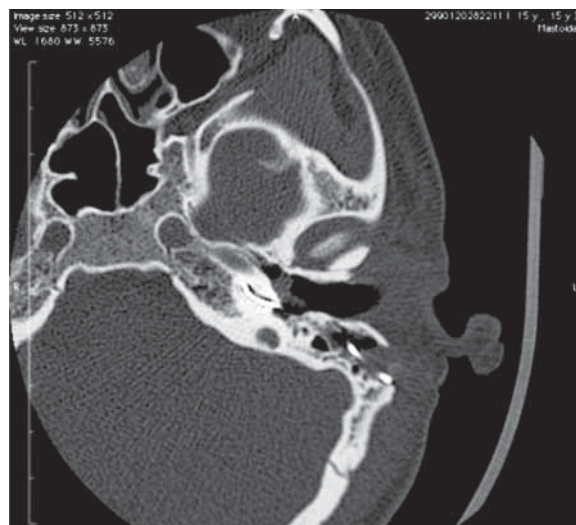
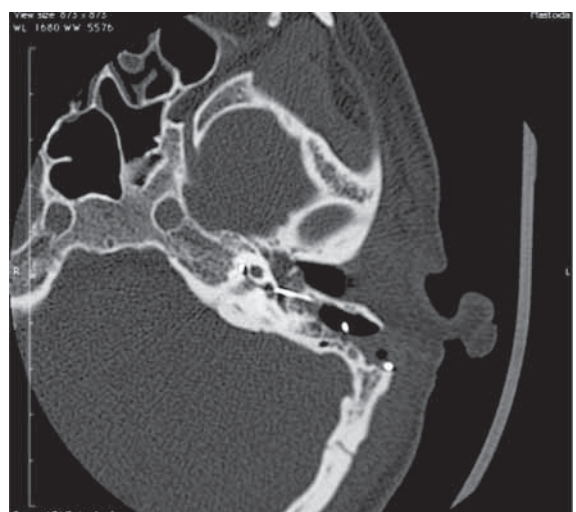
On the 4th day postoperatively, a control CT scan was performed, showing a intracochlear inserted electrode, but also gas inside the cochlea (suggesting perilymphatic fistula) (Fig. 3, 4).

FIGURE 3, 4. Intracochlear electrode array, surrounded by air bubbles scattered on all its length (postoperative CT)

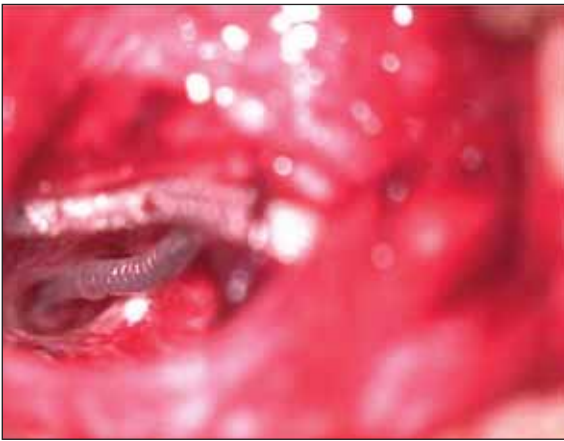
A decision was taken to operate the patient immediately. During revision surgery, we discovered the electrode array partially removed outside of the cochlea, although the sealing fascia was in good position around the cochleostomy (Fig. 5). There were no signs of infection.

FIGURE 5. *Electrode array partially extruded from the cochlea*

The vestibular syndrome in this particular case was due to a floating and extruded electrode array, although the cochleostomy was correctly performed and was not too large (0.8 mm), the FLEX28 and Compressed arrays differ very slightly in diameter (0.7 vs 0.8 mm), and the sealing of the cochleostomy with muscle tissue was satisfactory. We consider the appearance of this phenomenon in direct connection to the quality of the inserted electrode (probably too elastic and smooth, with conical shape, having an increased tendency towards migration out of the cochlea). Fixation of the electrode to a stable osseous margin is a solution that we have been using since this episode with this type of electrode. Other techniques of stabilising the implant and the electrode array have been cited into the literature (5, 6): bony hook at the mastoidectomy edge, bone pate harvested during surgery and obliterating the mastoid external opening.

The electrode was fully reinserted into the cochleostomy and fixed to the margin of the

posterior tympanotomy with KetacCem (glass ionomer cement), after which the cochleostomy was resealed with temporal fascia fragments and surgical (Fig. 6,7).

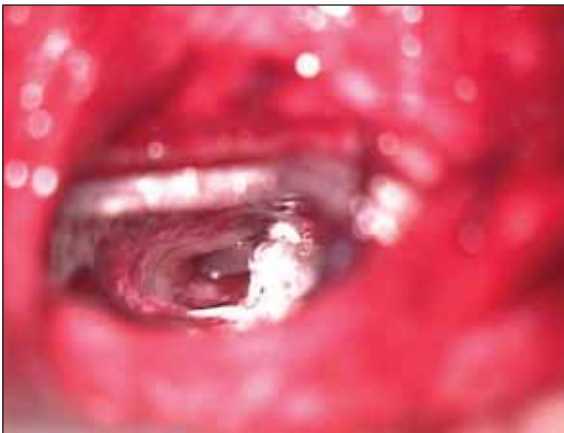
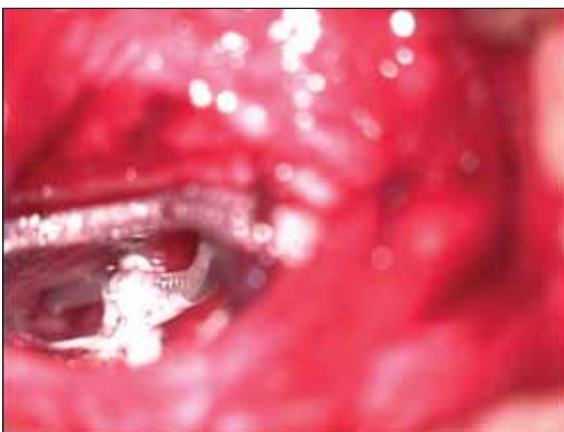
FIGURE 6, 7. *Reinsertion of the electrode array and fixing it to the posterior tympanotomy bone with glass ionomer cement*
